Investigation of the behaviors of various electroplated copper films during CMP

The behaviors of various electroplated copper films during CMP are important for removal mechanism and defect generation. This article was to study the characteristics of various copper films during CMP, including impurity effect and current density effect. Potentiodynamic polarization method was used to understand the removal behaviors. XRD and SIMS were applied to investigate the film texture and impurity content. Defect performance was decided in optical scan method and SEM reviewing. The research showed that (111)/(200) texture ratio determined removal rate and voids located in grain boundaries. Removal rate and void defects decreased with increasing (111)/(200) ratio. High (111)/(200) ratio has strong chemical resistance during polishing because (111) is the closed packed plane in the fcc structure. For impurity study, carbon and sulfur are impure atoms to weaken Cu grain boundaries to generate more void defects, but are insufficient to determine the removal rate. Furthermore, a novel phenomenon was observed that interconnect surface generate copper extrusion with time after polishing. AES proved

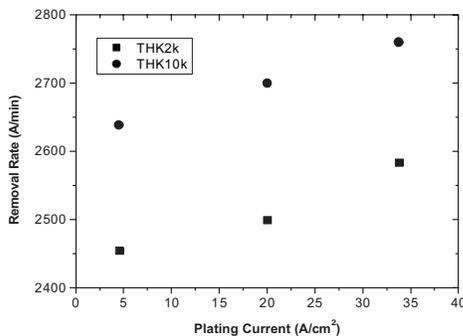
Figure 1: Removal rate versus current density and film thickness

Figure 1 is the copper CMP removal rate versus plating films with different current density in various thicknesses. Plating films with thick thickness and high current density achieve fast removal rate. It illustrated that Cu films with different thickness and plating current have different chemical resistance. Despite film thickness or plating current, use (111)/(200) ratio as an index versus removal rate, as shown in figure 2. The removal rate is significantly related to (111)/(200) ratio. It is known that the microstructural evolution of copper film via annealing is dependent on film stress [11]. During annealing, shrinkage or densification of the film by elimination of the grain boundaries during grain growth generates stress in the film.

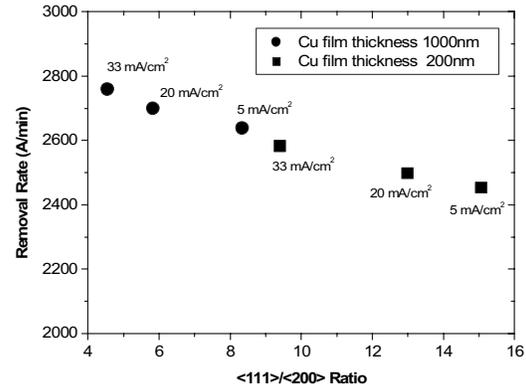
Figure 2: Value of (111)/(200) ratio versus removal rate

For fcc thin films, the (111) texture is favored by the surface and interfacial energy minimization, whereas the (200) texture is favored by the strain energy minimization [12]. It is speculate that the (111) texture has higher chemical resistance than other planes because (111) is the closed packed plane in the fcc structure [13]. To release film stress, (200) texture increase and (100) texture decrease. Therefore, thick film and high current density results in high stress to cause low (111)/(200) ratio and high removal rate. As described above, Cu film with high (111)/(200) ratio has high chemical resistance during CMP process. Figure 3 is the potentiodynamic polarization curves for copper films with various (111)/(200) ratio in slurry. The results show that corrosion current density increases with decreasing (111)/(200) ratio. The behaviors between corrosion current and removal rate are consistent with the trend of (111)/(200) ratio.

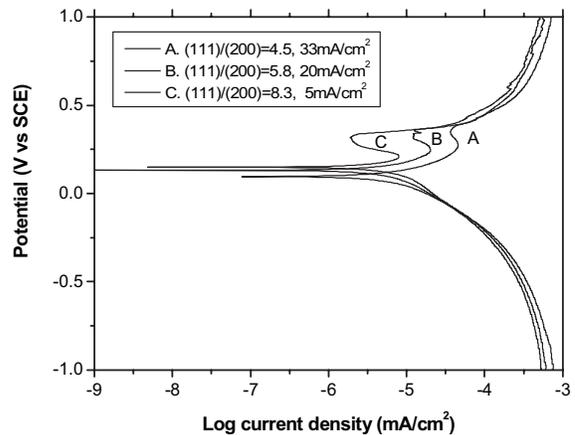
Figure 3: potentiodynamic polarization curves for copper films with various (111)/(200) ratio in slurry

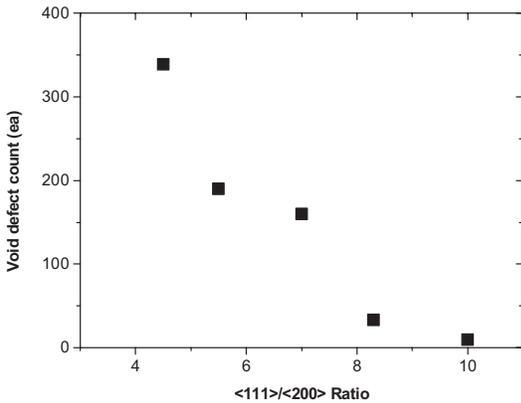
Figure 4: Amount of void defects versus (111)/(200) ratio

During polishing, grain boundaries are easily attacked by slurry to generate voids because atoms are more loosely packed in the grain boundaries than in the crystal lattices. In brief, the copper film texture with high (111)/(200) ratio has strong chemical resistance in slurry. These findings suggested that weak chemical resistance achieve more void-defects generation. Applying different current density to generate various copper film texture in 1000nm to prove that the amount of void defects increases as the (111)/(200) ratio decreases, as shown in Figure 4. In summary, the void defects are highly associated with the texture of grain boundaries.

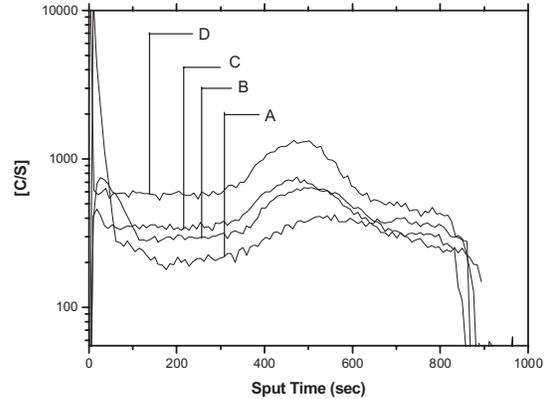
Figure 5a: SIMS carbon analysis for different Cu films

Moreover, understanding the role of impurities is also important to figure out the polishing performance of various Cu films. The impurity incorporation phenomenon can be explained by curvature-enhanced accelerator coverage model (CEAC) that was recently developed by West et al. and Moffat et al [14,15]. It is believed that electrolyte bath and current density are two factors for film impurities in the same annealing condition. To study impurity effect, use plating baths with four additive concentrations in identical (20 mA/cm², 1000nm) current densities and anneal condition to generate four Cu films with different impurity content in the same texture. SIMS analysis and XRD measurement showed varied carbon/sulfur content and almost the same (111)/(200) ratio for these four Cu films, as shown in Figure 5a,b. It implied that the small amount of impurities is insufficient to change the texture ratio of copper film. Figure 6 revealed that removal rate are not change with carbon/sulfur impurity, but void defects increases with raising impurity content. One reason could be that removal rate regards the performance of whole copper surface including grains and grain boundaries, but void defect is mainly related to the strength of grain boundaries. It speculated that high impurity could generate more defect during polishing because the impure atoms weaken Cu grain boundaries. In a word, impurities are insufficient to determine the removal

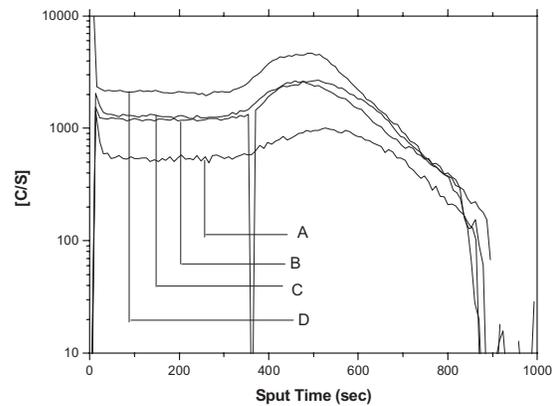
Figure 5b: SIMS sulfur analysis for different Cu films

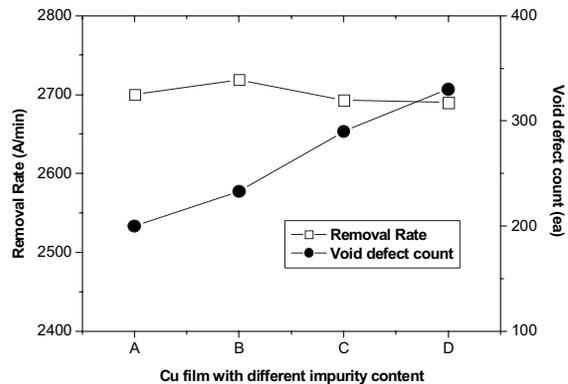
Figure 6: Removal rate and voids defect versus different impurity copper film (A<B<C<D)

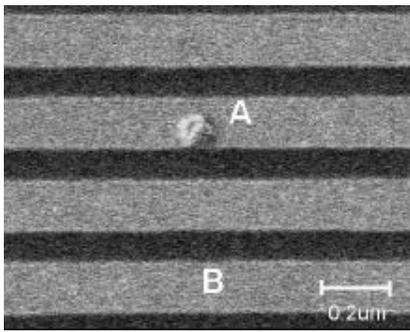
Figure 7a: SEM image of extrusion (after polishing 12hr)

Furthermore, an interesting phenomenon was observed that copper extrusion was formed in metal surface through about 12 hours after polishing, as displayed in figure 7a. Figure 7b is the Auger measurement that detected sulfur in the extrusion location as compared with normal area. In addition, the Auger mapping method provided direct evidence to prove the sulfur content of extrusion location, as shown in Figure 7c. Cu-S is not easy to remove after annealing due to its high bonding energy (276 kJ/mol) as compared with Cu-Cu (176 kJ/mol). Moreover, it was found that extrusions on narrow line are more than on wide line. According W.Zhang's report [16], the geometry effect caused high level impurities trapped in narrower line. As mention above, the phenomenon of copper extrusion is closely correlated to Sulfur impurities.

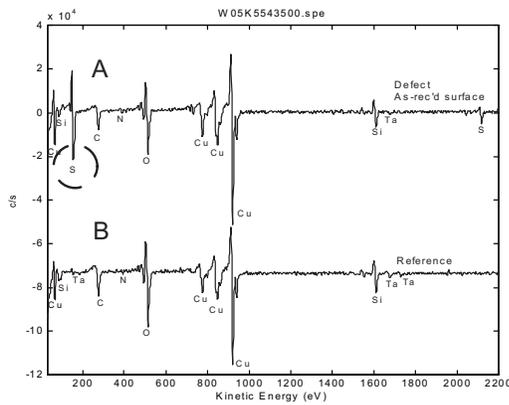
Figure 7b: AES sulfur map for extrusion area
